*EZ Street* has a number of standard benefits that are independent to any paving project: Firstly, there is no tack coat or mixing required prior to application of *EZ Street* Asphalt — *EZ Street* is ready to use.

ainroad Lower Mainland Contracting is responsible for the maintenance of Highway 99. This Ministry of Transportation & Infrastructure Provincial Highway is one of the major highways heading south from the Lower Mainland / Vancouver area towards the U.S. Border. With a traffic count of over 50,000 vehicles per day, Highway 99 is considered a Class A category road for maintenance work.

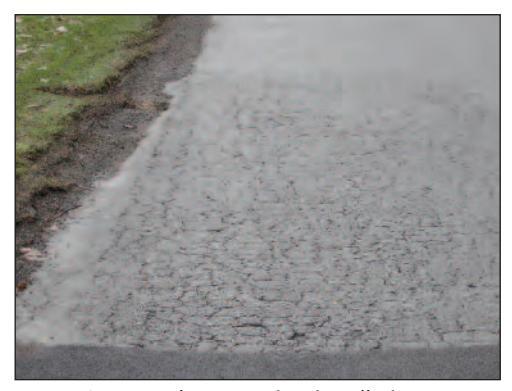
One month post project installation – Note that existing pavement showing wear is not encroaching into new EZ Street paved surface.

are performing as well today as the day they were installed. The tracks of the tree roots are still visible in a couple of locations but this is to be expected as the roots were never removed. No potholes have appeared in any of the repairs performed in the moderately damaged sections.

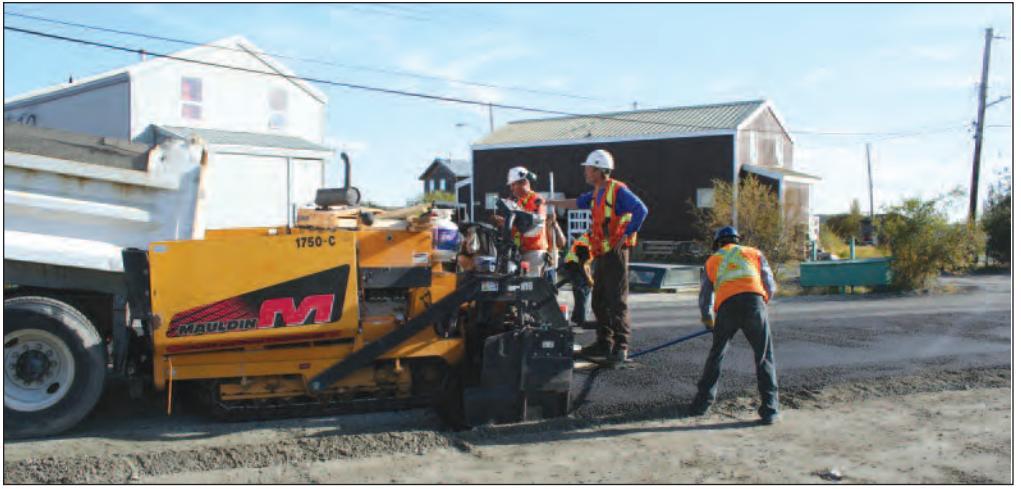
Optimal Compaction, with no heat/time limitations

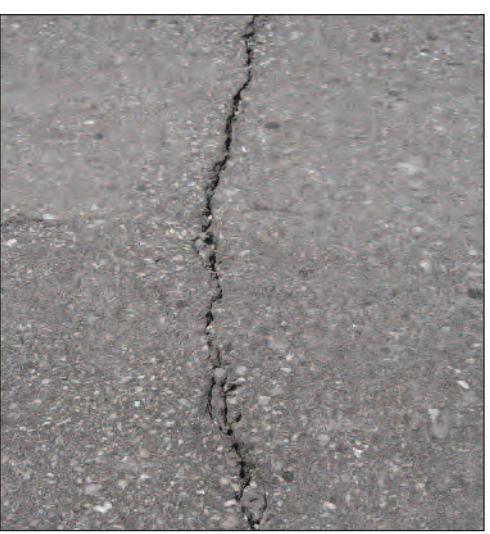
Cracks in the asphalt (full depth crack)

As can be expected with the concrete slab road base and inbuilt movement, both surfaces show signs that joint movement has occurred. The traditional asphalt has cracks across all of the joints with some additional (new) cracking visible in the surface. The cracks were inspected close up (as per photo) and the cracks were found to penetrate all the way through the surface into the base. To keep this section of the pavement water proof, crack sealing will have to be performed through the length of the pavement life. This will be an

ongoing maintenance issue for regular asphalt through the life of this pavement.

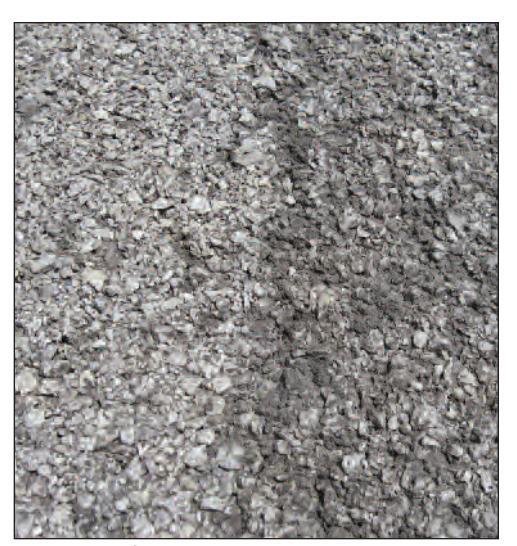
Self-healed crack in the EZ Street (visible scribe mark only)

EZ Street also shows some signs of cracking across the joints / expansion joints. Unlike the regular asphalt, when examined up close, the cracks show to be lines on the surface of the layer with no penetration through the mat. It visibly looks more like a scribe mark on the surface than a crack at all. Any cracks that had appeared in the pavement seem to have self-healed.

EZ Street has 'self-healing' properties. The product itself will remain "live" for a significant period of time. It will not move, deform or rut but will enable the material to reform to heal any cracks that appear. If cracks do appear due to higher than normal pavement movement such as the concrete slab joints in this trial then the cracks are able to re-join or heal leaving

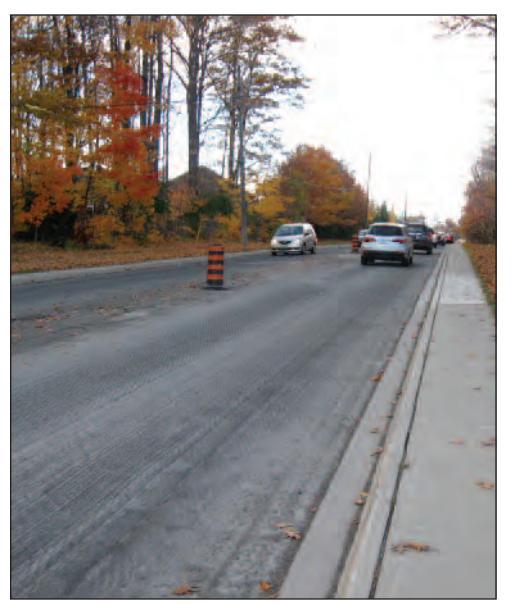
Existing road milled (50mm)

of the excessive road noise (70km speed limit). 50mm was milled from the old surface and 50mm of EZ Street Polymer Modified Cold Asphalt was installed.

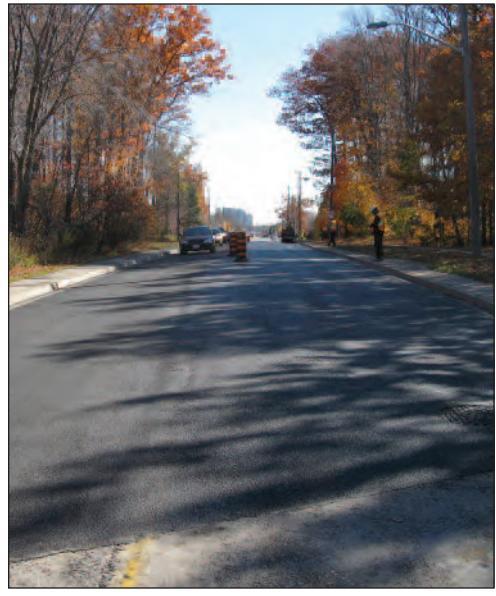
Traffic ready immediately following installation

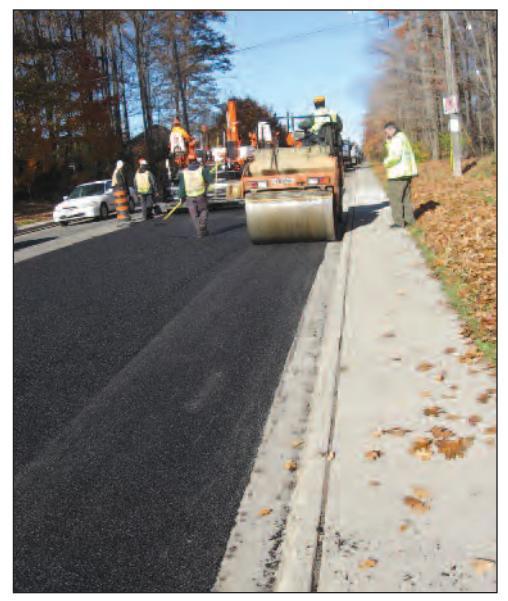
EZ Street installation

The surface was installed using standard paving equipment, and compacted with a standard combination roller and a pneumatic tire roller.

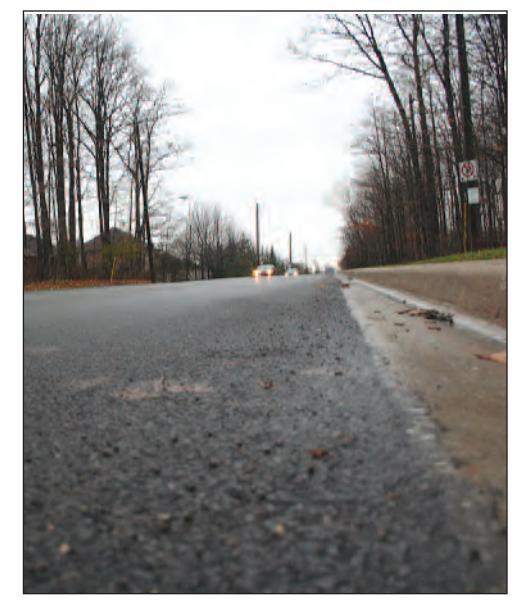
EZ Street surface
